Manhole Inspection Summary

Manhole # S27M__033MH

Insp Date: **5/8/08 2:16 PM**

Location Address: **637 Nanticoke St**

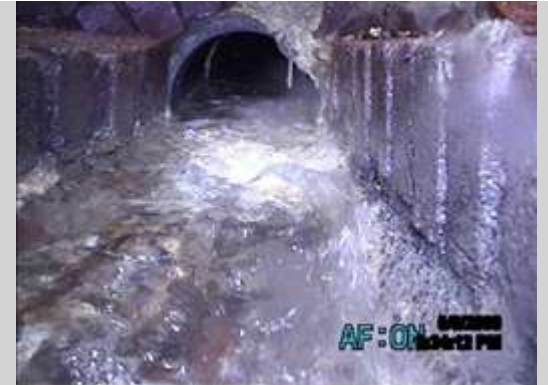
12 O'Clock Outflow

8 in. Circular Gravity Sewer
Pipe Out @ 12 O'Clock

Pipe Height: **7.2** (in.) Rod and Bar (Angled)
Pipe Material: **Clay** ☐ Pipe Lined
Invert Depth: **8.88** (ft.) Flow Characteristics: **Fast**
Deposits: ☒ None ☐ Mud ☐ Sludge ☐ Debris ☐ Grease
Silt Depth: **0** (in.) Deposits Extent:
Infiltration: **None** Pipe Seal Cond: **Sound**

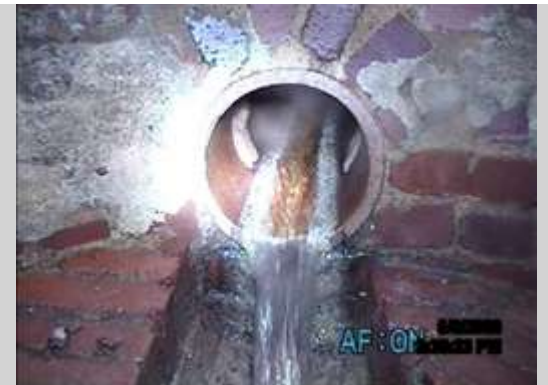
6 O'Clock Inflow

8 in. Circular Gravity Sewer
Pipe In @ 6 O'Clock

Pipe Height: **8.4** (in.) Rod and Bar (Angled)
Pipe Material: **Clay** ☐ Pipe Lined
Invert Depth: **8.03** (ft.) Flow Characteristics: **Fast**
Deposits: ☒ None ☐ Mud ☐ Sludge ☐ Debris ☐ Grease
Silt Depth: **0** (in.) Deposits Extent:
Infiltration: **None** Pipe Seal Cond: **Sound**

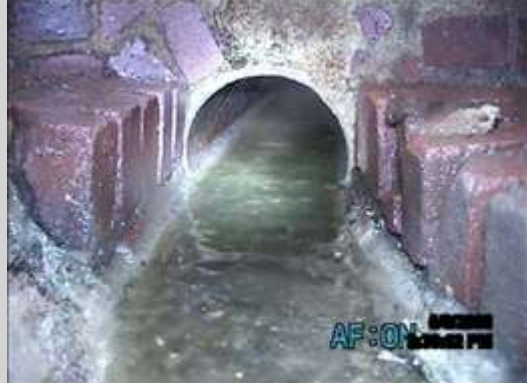
7 O'Clock Inflow

Pipe In @ 7 O'Clock

Pipe Height: **7.2** (in.) Rod and Bar (Angled)

Infiltration: **None** Pipe Seal Cond: **Sound**
